Inspection & Replacement Criteria of Rubber/Metal Composites

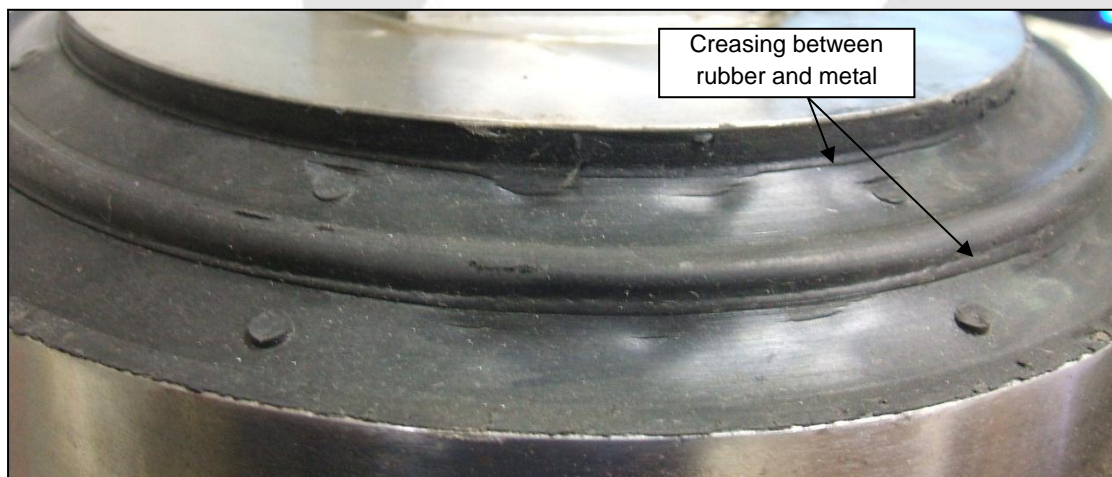
Figure 2: Rubber creasing in a bush after 200,000 km service

Following installation of rubber product, and operational use, creasing may occur between the metal and rubber parts. Creasing is partly a consequence of the anti-ageing wax inherent in rubber that protects it from ozone and other environmental factors. It can become especially noticeable on bulging rubber.

Creases may falsely appear like cracks or tears in the rubber. Creasing in rubber during or after loading is harmless and does not affect the integrity of rubber springs.

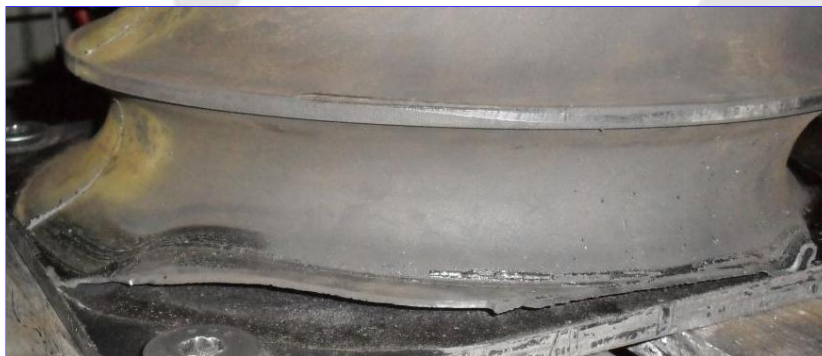
Figure 7: Failure of bond between rubber and metal

With most rubbers, the occurrence of dry rubber-metal bond failure usually indicates a manufacturing process error, but in some cases, the bond strength may be moderate only. In such cases, a product shall be evaluated carefully and replaced if there is a defect of the bond larger than 10 mm of depth. Figure 7 shows an example of a debond between the rubber and metal surface.
